United States Environmental Protection Agency Washington, D.C. 20460	
Water Compliance Inspection Report	
Section A: National Data System Coding (i.e. PCS)	
Transaction Code 1 N 2 5 3 DC0000094 11	yr/mo/day 12 10/08/04 17
Inspection Type 18 C	Inspector 19 S
Fac Type 20 2	Remarks 21 66
Inspection Work Days 67 10 69	Facility Self-Monitoring Evaluation Rating 70 5
B1 71 N	CA 72 N
73	74 75 80
Section B: Facility Data	
Name and Location of Facility Inspected (For industrial users discharging to POTW, also include POTW name and NPDES permit number)	Entry Time/Date 9:00 AM August 4, 2010
Permit Effective Date 06/19/2009	Exit Time/Date 5:30 PM August 4, 2010
Permit Expiration Date 06/18/2014	Other Facility Data (e.g., ISC NAICS, and other descriptive information)
Name(s) of On-Site Representative(s)/Title(s)/Phone and Fax Number(s) 1. Fariba Manvi, Lead Environmental Engineer (PEPCO), 202-331-6641 2. Joe Camerini, Plant Manager (NAES), 202-388-2513 3. Heather Brinnerhoff, EHS Manager (NAES), 202-388-2534 4. John Keiller, (PEPCO/Environment), 703-253-1762 5. Aleta Finney, (PEPCO/Environment) 6. Shirley Harmon, Power Plant Assistant Manager, (PEPCO Energy Services, Inc.)

**Water Compliance

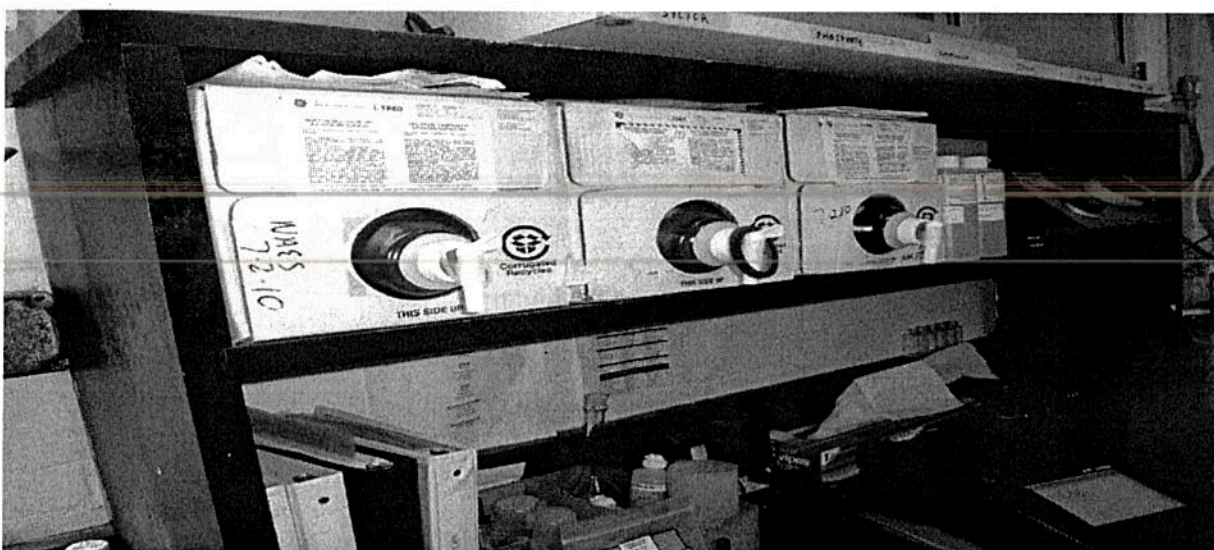
Photo 1: Laboratory equipment and pH buffer solutions. The buffer solutions had not expired at the time of inspection.

The facility's in-house laboratory is used to monitor effluent samples for residual chlorine and pH. Samples for other analytes are shipped off-site to Microbac Laboratories, Inc. in Baltimore for analysis. A review of the facility's calibration log books indicated that the lab uses a 3-point procedure to calibrate its pH meters every month. The pH buffer solutions used in the calibration were all current at the time of this inspection (**Photo 1**). Both PEPCO's and Microbac's labs were not inspected.

The facility's in-house laboratory is used to monitor effluent samples for residual chlorine and pH. Samples for other analytes are shipped off-site in cooler boxes (**Photo 13**) to Microbac Laboratories, Inc. in Baltimore for analysis. The samples are first kept in a refrigerator (**Photo 14**) before the lab picks them up. The facility's in-house lab utilizes a GE Infrastructure Water and Process Technologies pH Meter. A review of the facility's calibration log books indicated the uses a 3-point procedure to calibrate its pH meters every month. The pH buffer solutions used in the calibration were all current at the time of this inspection (**Photo 1**). Both PEPCO's and Microbac's labs were not inspected.

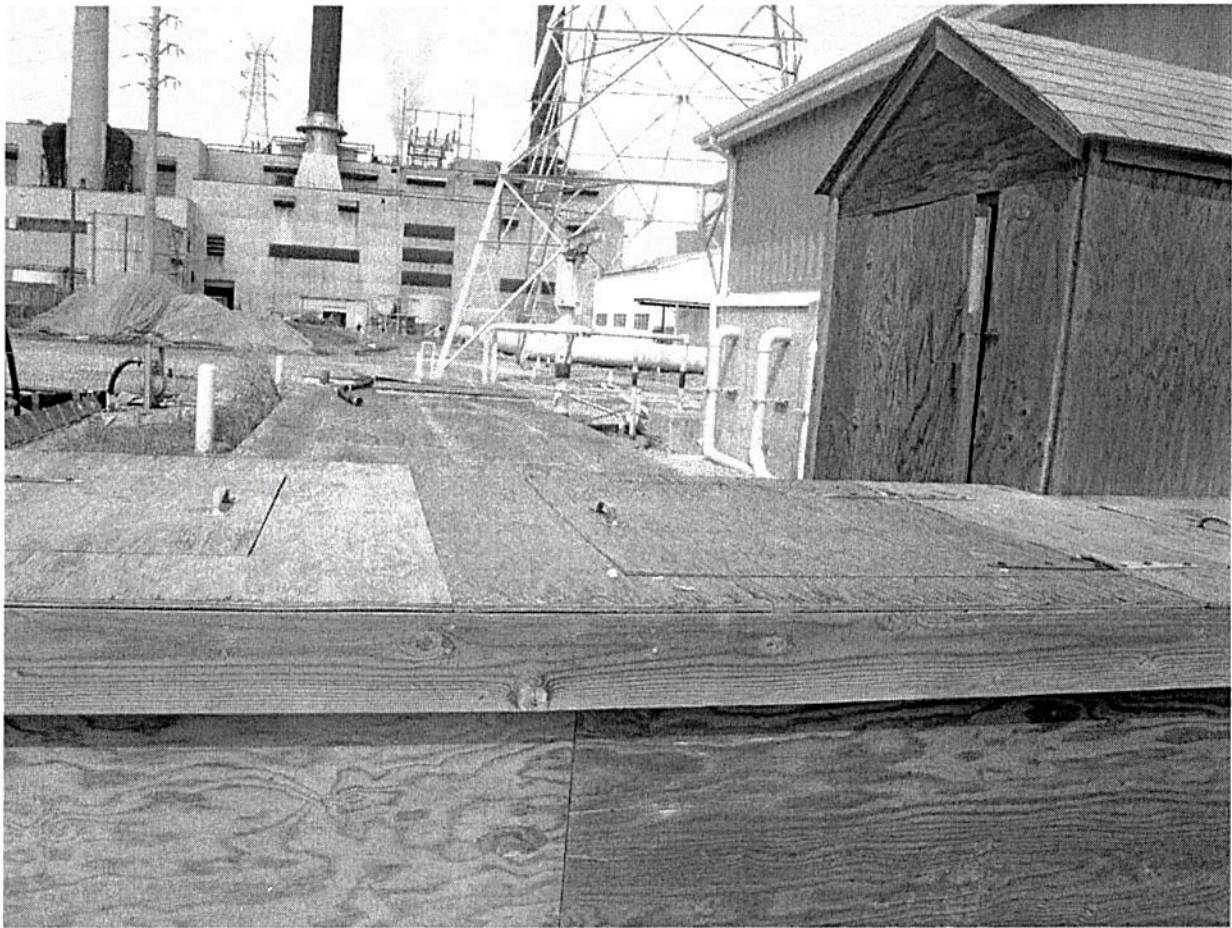
The facility has two oil-water separators: (i) oil-water separation/settling system at Outfall 201, which was designed to remove oil and grease from utility wastewater and a No. 2 oil loading area (**Photo 2**). Monitoring point 201 is the discharge point from this oil-water separator. At the time of inspection, the oil-water separator was out of service because it was being replaced with a new system (**Photo 3**). The facility representatives stated that last summer during cleaning and inspection of the oil-water separator at outfall 201, hair line cracks were discovered inside the separator, so the facility decided to replace it with a new one. The facility informed EPA in an e-

Photo 2: Old oil/water separator (at Outfall 201) covered with plywood. The old oil/water separator is being replaced with a new one (blue building on the right). Currently, the wastewater is being treated using granulated activated carbon.

mail dated May 27, 2010 of the plan to replace the separator and use of a portable oil-water separator until construction of the new one is completed.

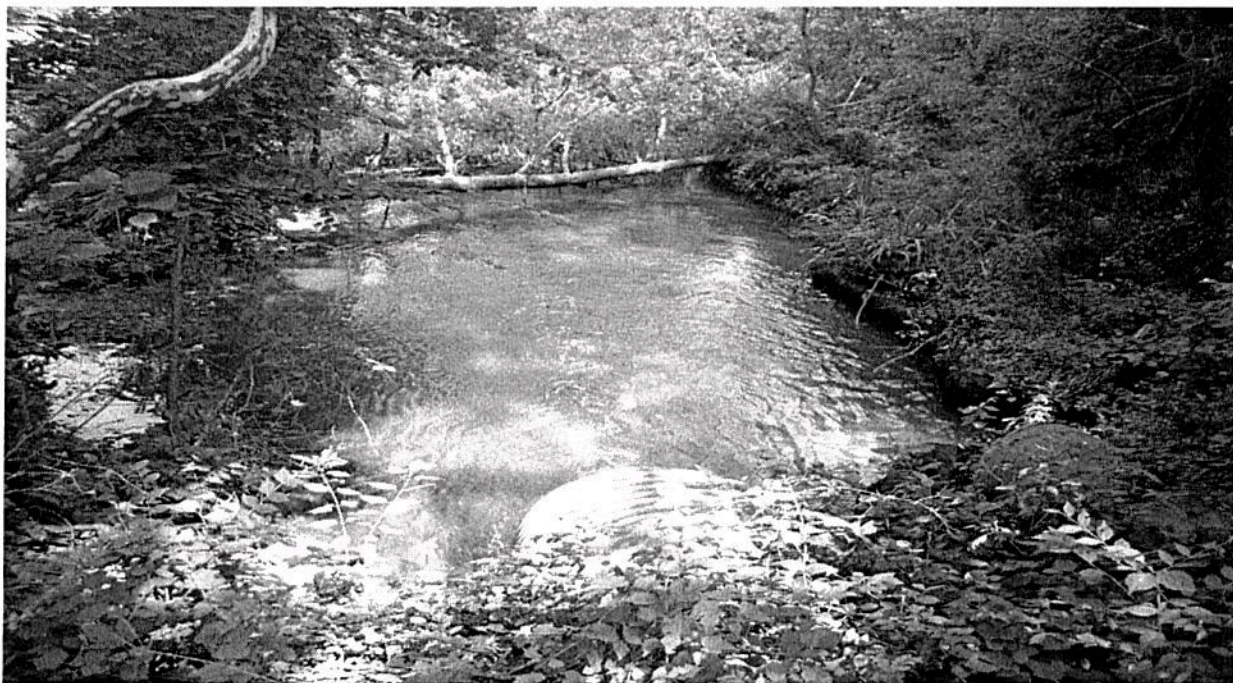
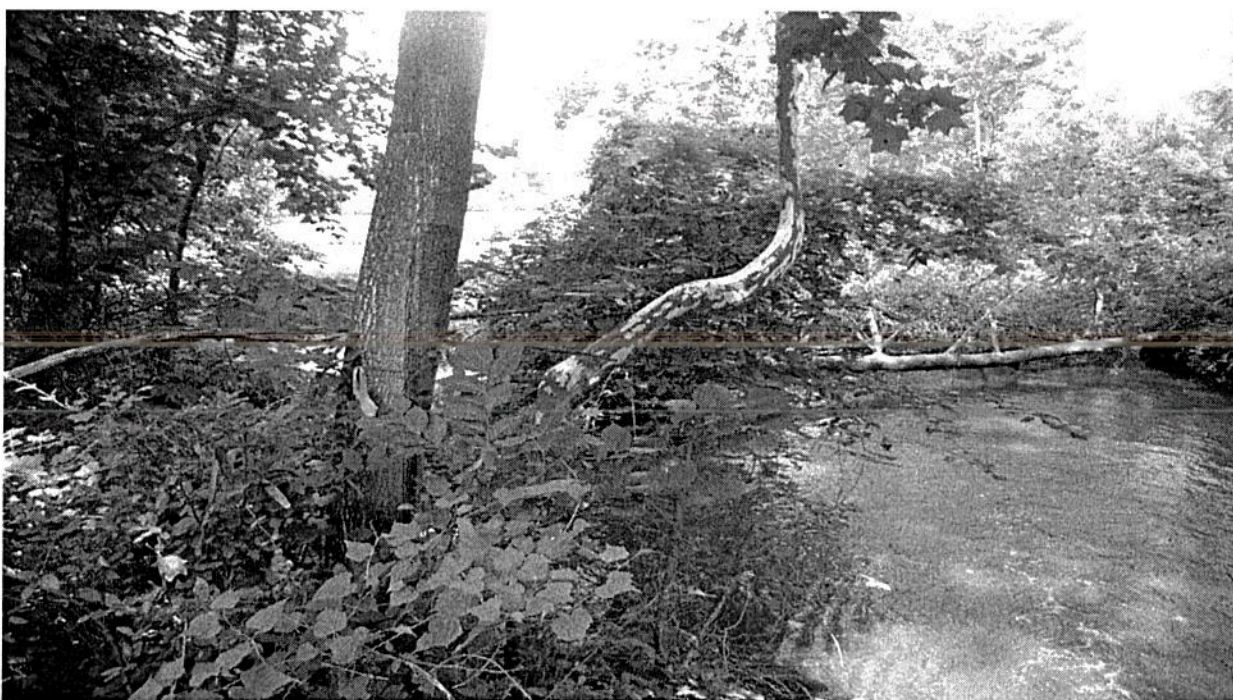
Photo 8: Outfall 013 at the Anacostia River. Turbidity can be seen in the water. The outfall was discharging at the time of inspection.

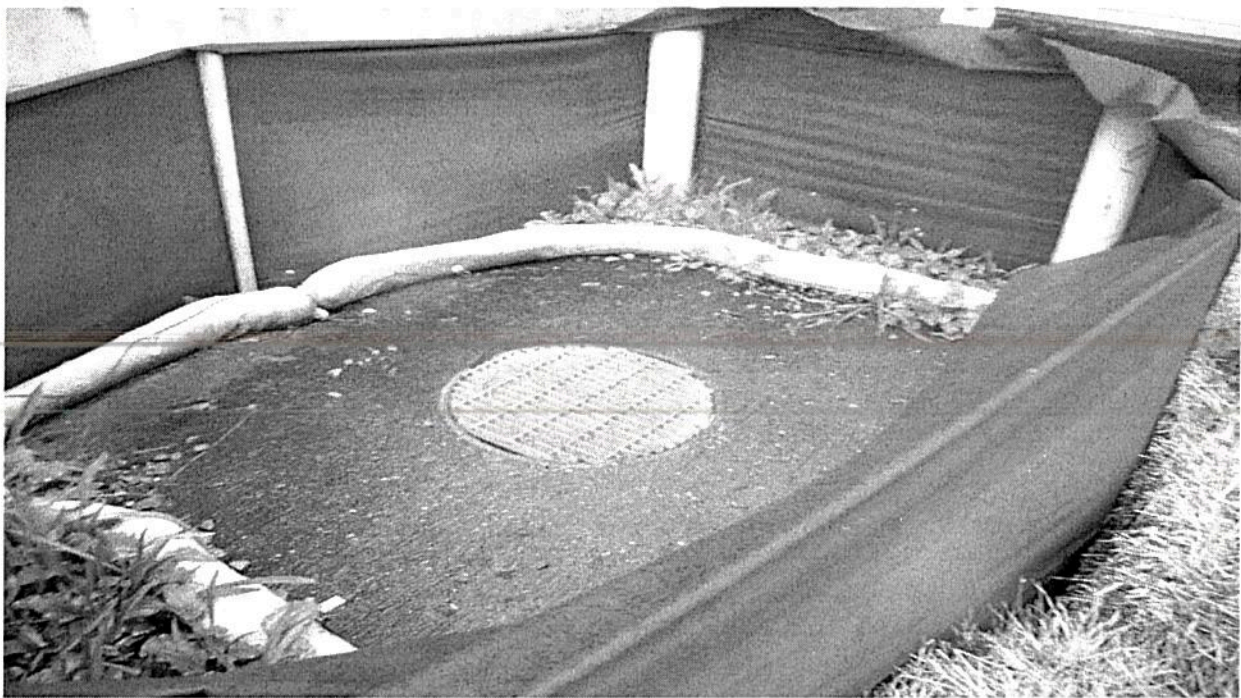
Photo 9: Hay straw, turbidity curtain and oil boom/filter cloth around an inlet/manhole, which is a sampling point for Outfall 013.

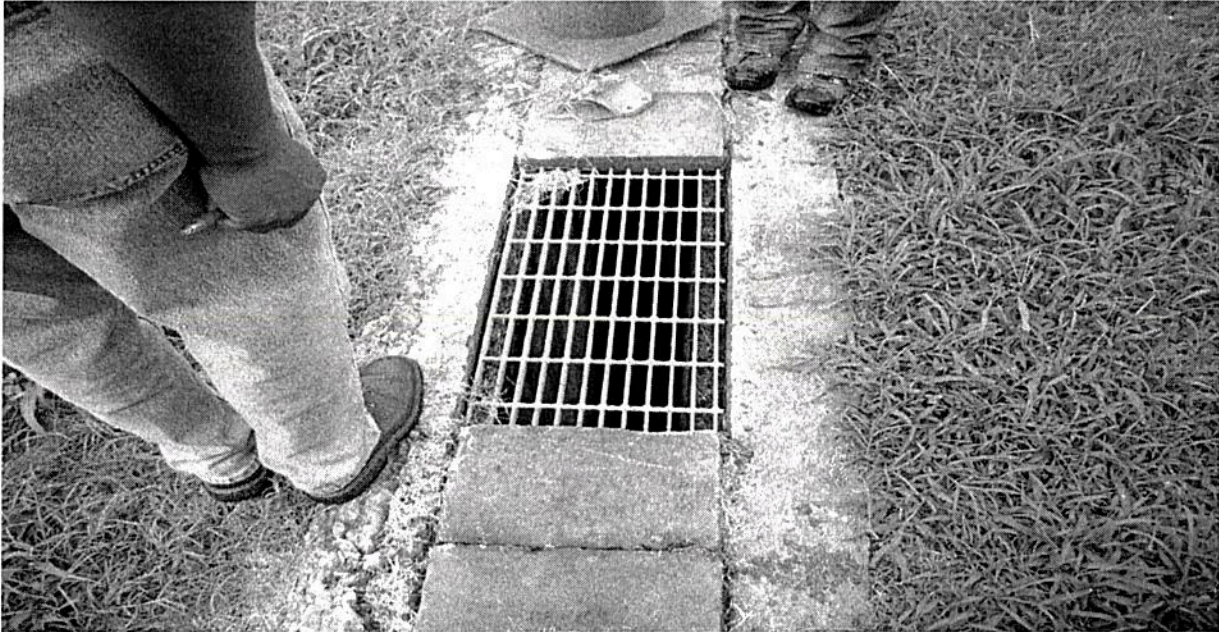
3. Monitoring point 101 is manhole K for monitoring stormwater from the transformer area. It is to be retrofitted for monitoring stormwater as described in the permit. The outfall discharges to the Anacostia River (**Photo 10**).

Photo 10(a): Manhole K, which is a monitoring location for Outfall 101.

Part VIII of the permit (i.e. Special Conditions) requires the facility to submit for comment to EPA and DDOE, a plan (with an implementation schedule) to retrofit manhole K ((**Photo 10**) into a reliable monitoring point for stormwater for Outfall 101. The goal is to ensure that the manhole is not affected by high tides. According to the facility representatives, plan submittals to EPA and DDOE have been done; proper arrangement has been made for financing; contracts for engineering services have been executed; and construction and/or equipment acquisition is on schedule.

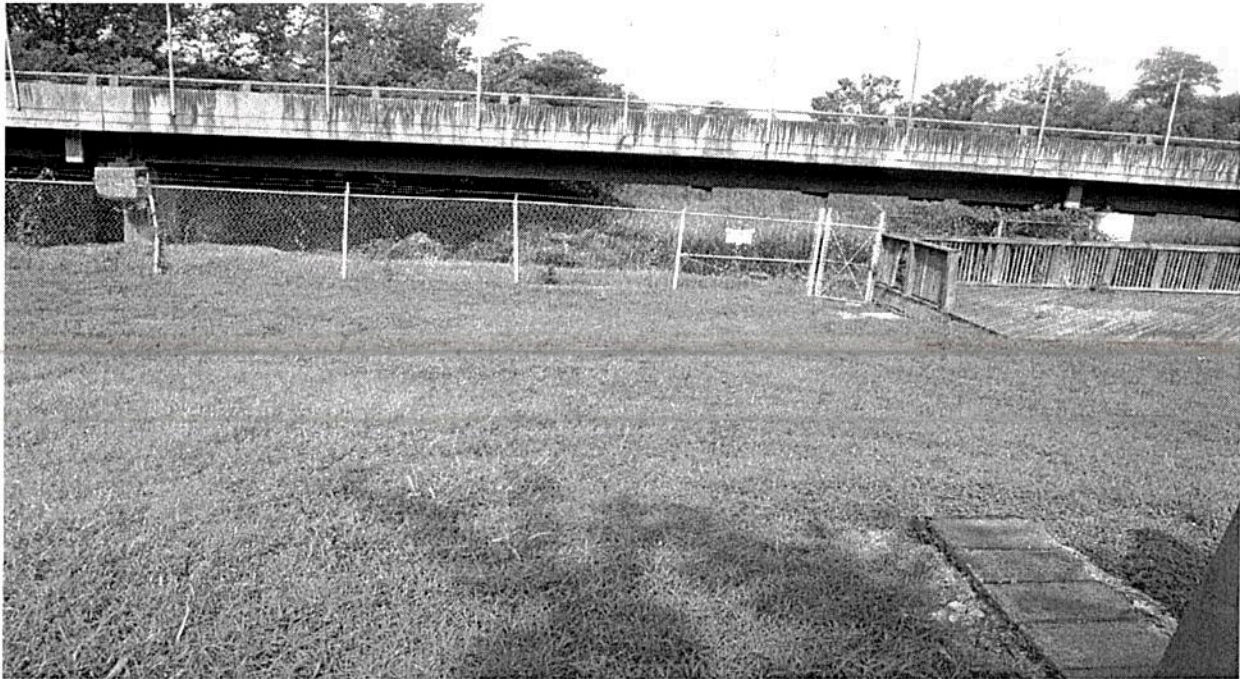
(1) # At Outfall 101, the inspectors could not see the receiving waters because the outfall was under tall thick grass.							
(2) ¶ At Outfall 013, no plume in the river's wetlands could be distinguished due to the muddy pool of water where 013 discharged.							
(Sections M and N: Complete as appropriate for sampling inspections)							
SECTION M - SAMPLING INSPECTION PROCEDURES AND OBSERVATIONS (Further explanation attached <u> </u>) <u>No samples were taken</u>							
<input type="checkbox"/> GRAB SAMPLES OBTAINED <input type="checkbox"/> COMPOSITE OBTAINED <input type="checkbox"/> FLOW PROPORTIONED SAMPLE <input type="checkbox"/> AUTOMATIC SAMPLER USED <input type="checkbox"/> SAMPLE SPLIT WITH PERMITTEE <input type="checkbox"/> CHAIN OF CUSTODY EMPLOYED <input type="checkbox"/> SAMPLE OBTAINED FROM FACILITY'S SAMPLING DEVICE COMPOSITING FREQUENCY <u> </u> PRESERVATION <u> </u> SAMPLE REFRIGERATED DURING COMPOSITING: <input type="checkbox"/> YES <input type="checkbox"/> NO SAMPLE REPRESENTATIVE OF VOLUME AND NATURE OF DISCHARGE

Photo 10(b): Outfall 101 discharges to the Anacostia River at the facility's intake point (tall grass under the bridge). The outfall was submerged and covered by the grass under the bridge. The monitoring location is to be retrofitted so that it does not get impacted by high tides from the river

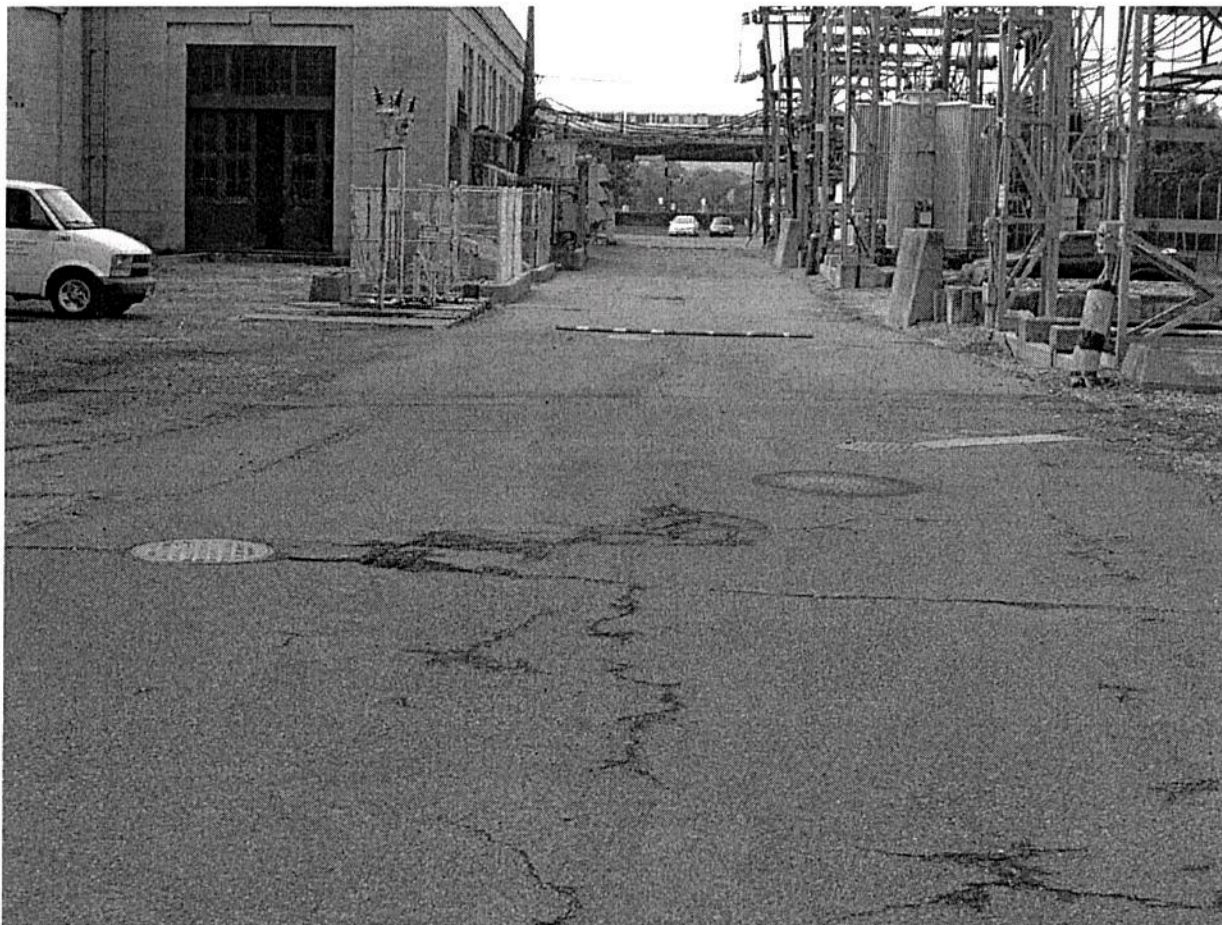
Photo 11: Drainage area for Outfall 101 comprises of the transformer area and access road on the west of the power generating building.

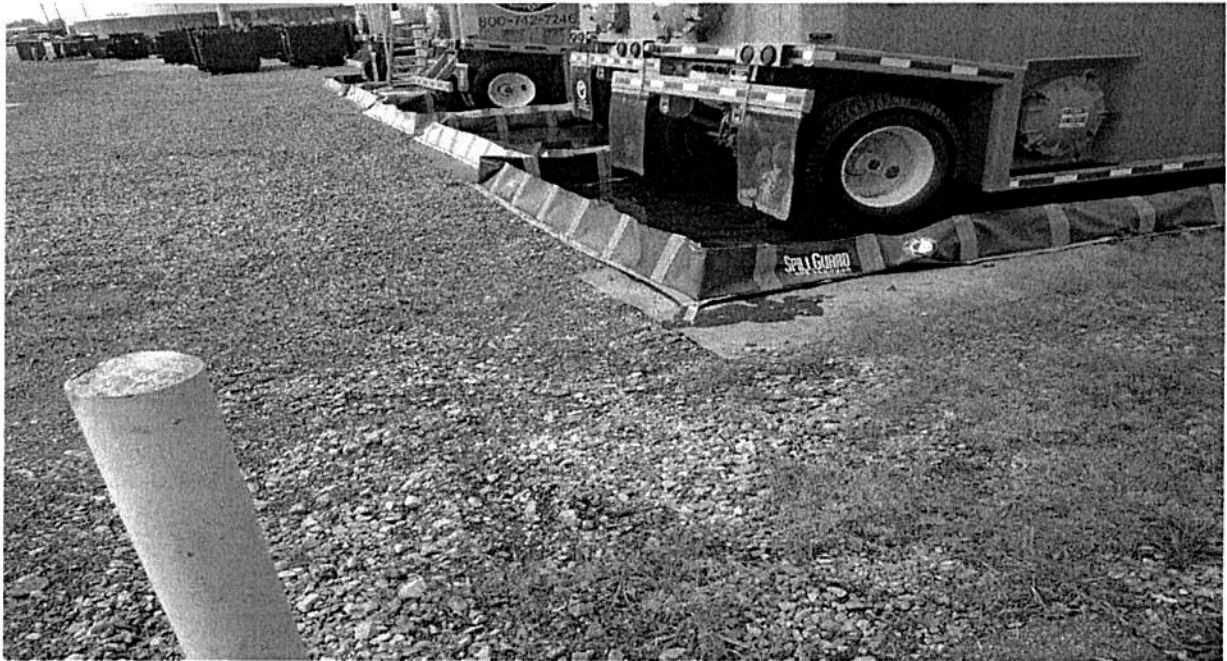
Photo 12(a): Spill guards are used around equipment that contains oil.

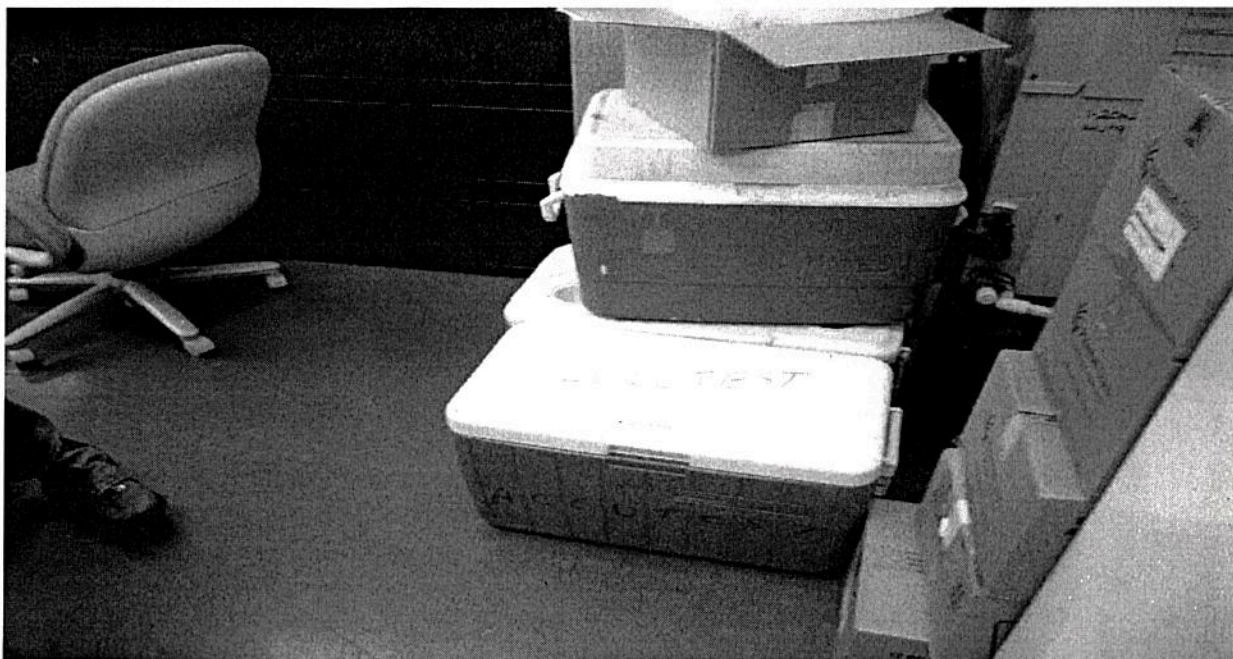
Photo 13: Cooler boxes for shipping samples to an offsite laboratory.

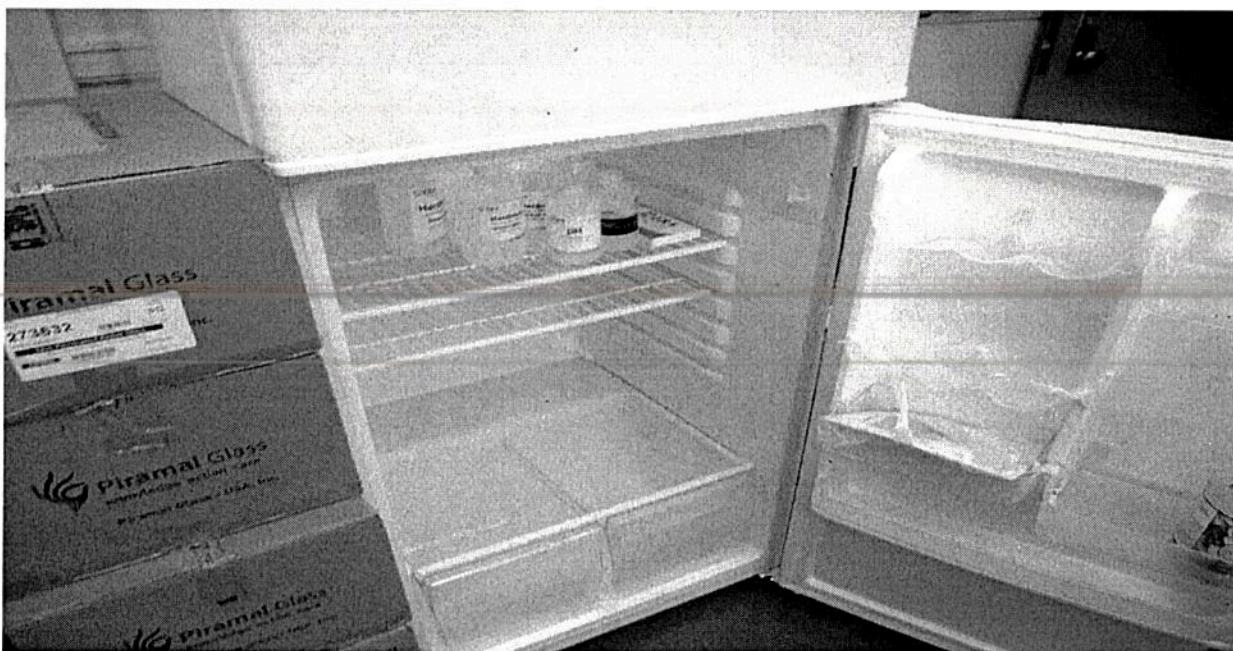
(d) SAMPLE COLLECTION PROCEDURES ARE ADEQUATE.		<u>X</u> YES <u> </u> NO <u> </u> N/A
(i) SAMPLES REFRIGERATED DURING COMPOSITING (No thermometer in refrigerator)		<u>X</u> YES <u> </u> NO <u> </u> N/A
(ii) PROPER PRESERVATION TECHNIQUES USED		<u>X</u> YES <u> </u> NO <u> </u> N/A
(iii) FLOW PROPORTIONED SAMPLES OBTAINED WHERE REQUIRED BY PERMIT		<u> </u> YES <u> </u> NO <u>X</u> N/A
(iv) SAMPLE HOLDING TIMES PRIOR TO ANALYSES IN CONFORMANCE WITH 40 CFR 136.3		<u>X</u> YES <u> </u> NO <u> </u> N/A

Photo 14: Refrigerator for storing samples before they are taken to an offsite laboratory. However, there was no thermometer inside.

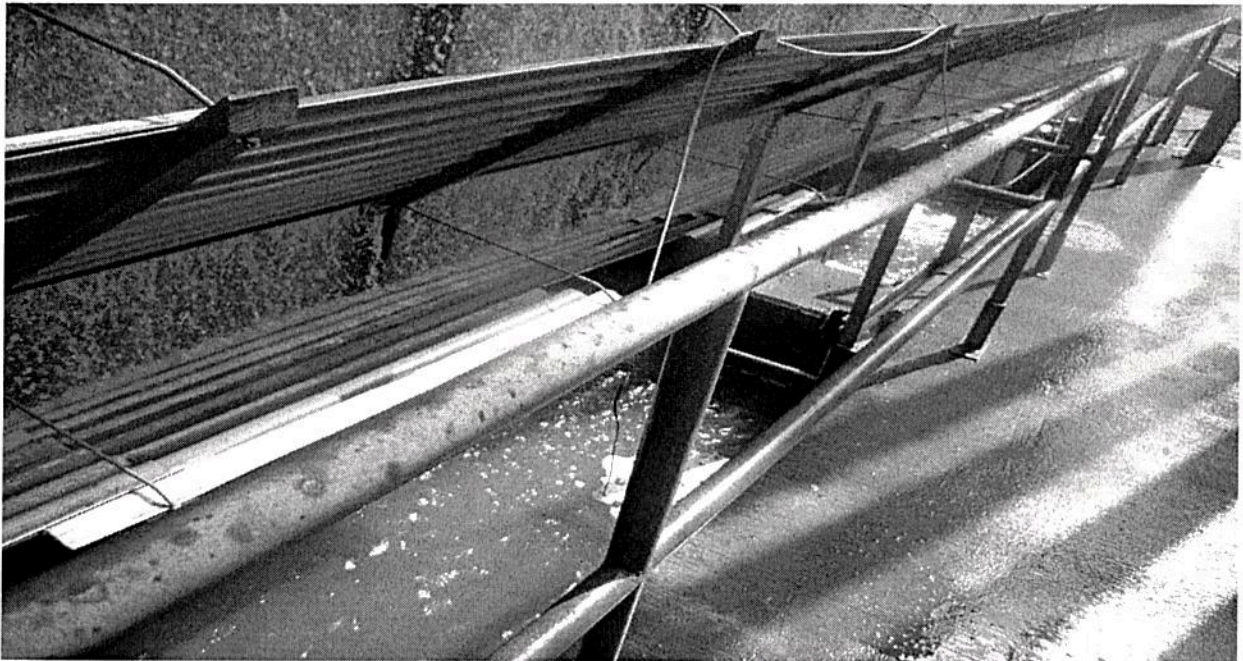
NAES staff samples and conducts self-monitoring activities at Outfalls 201, 202, 203, and 013 while PEPCO staff samples Outfall 003. Effluent samples for Outfall 013 are collected at a manhole prior to the end of discharge pipe (**Photo 9**). Samples for Outfalls 003 and 201 (oil-water separators) are collected at the end of the treatment system discharge pipe. Samples for Outfalls 202 and 203 are collected from the cooling tower sumps (**Photo 15**).

4. Monitoring point 201 is the discharge point for the treated wastewater coming out of the oil-water separator.
5. Monitoring points 202 and 203 have two sets of monitoring requirements and effluent limits. These requirements vary depending on whether or not, there is a discharge of cooling tower blow down or cooling tower wash water. There was no cooling tower blow down discharge during the inspection (**Photo 15**).

Photo 15: Outfall 202 receives blow down discharge from Unit 15. Outfall 203 receives blow down discharge from Unit 16.

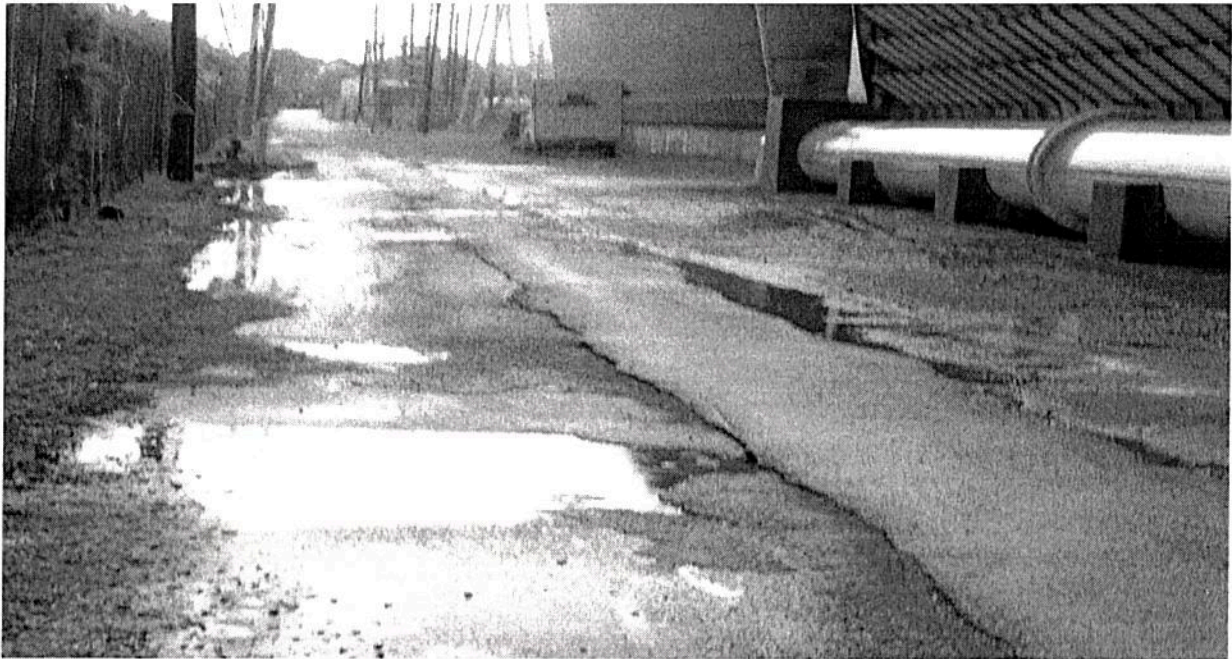
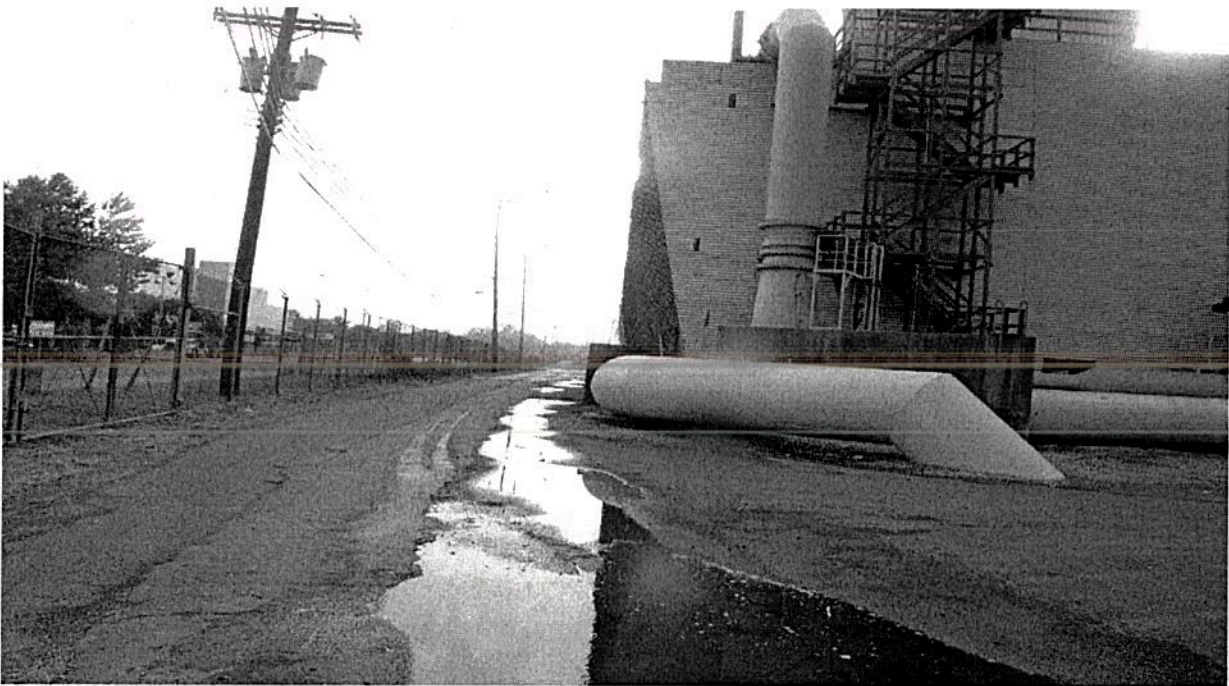
The inspectors observed water/runoff flowing along the perimeter/chain link fence inside the facility (**Photo 16**). Although, the facility representatives claimed that the observed runoff was stormwater runoff there was no rain to vindicate the claim. Instead, it is clear that the runoff was from the cooling towers (**Photo 16**). This runoff was observed entering the DC Municipal Separate Stormwater Sewer System (MS4) through sewer sheds/manholes on the property fence (**Photo 17**).

Photo 16: Spillover water from the cooling tower flows along access road.
